TEST REPORT

Sample Name : Industrial Rugged Full Metal 2.5" SATA/SAS HDD & SSD Mobile Rack
for External 3.5" Drive Bay with Key Lock & Thumb Screw Design

Model Name : MB491SKL-B

2. VIBRATION TEST

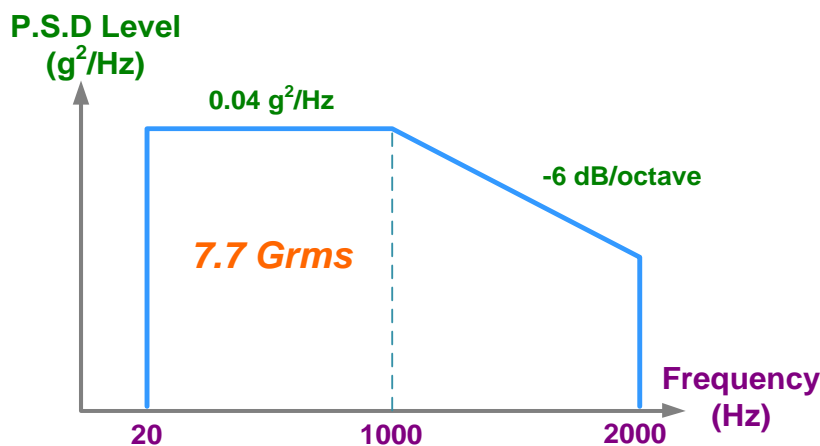
Vibration waveform : Random waveform

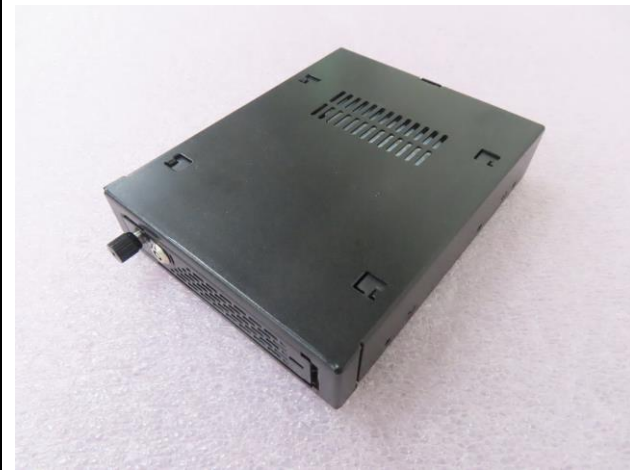
Before testing

The appearance of unit was normal

After testing, visual inspection showed no physical defect and functional degradation on unit.

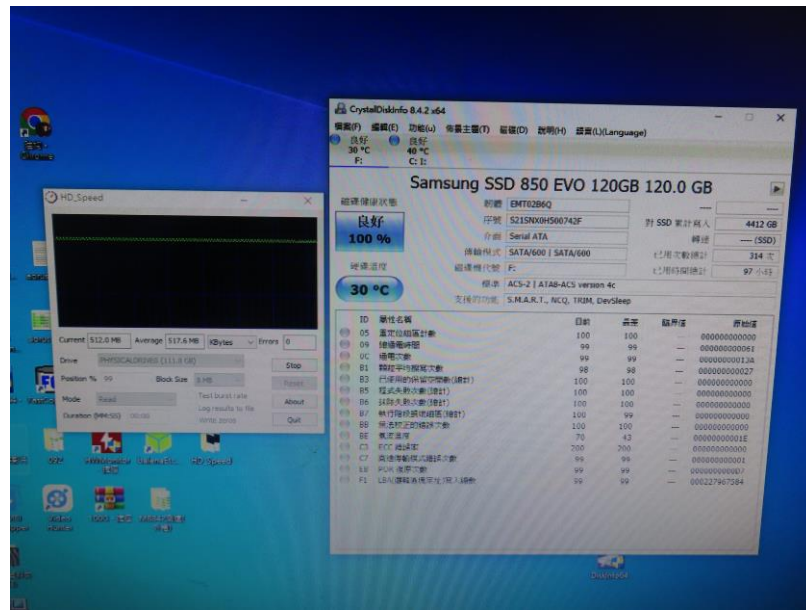
Before testing

The function of unit was normal

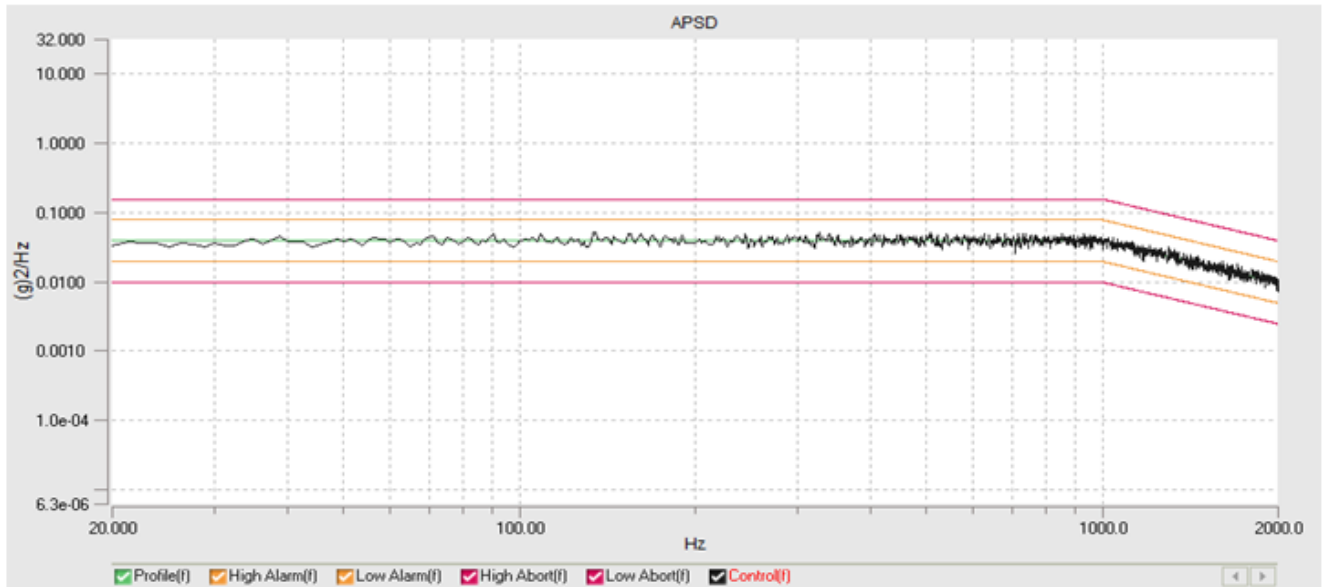
【Z axis】

Current Level:0.00 dB	Demand RMS: 7.692 g	Control RMS:7.708 g
Frame Time:0.8000 (s)	Lines:1600	dF:1.3 Hz
DOF:152	Current Level Time:01:00:00	Remaining Time:00:00:00
